Safe Routes to Schools Improvement Plan
Santa Rita Elementary School
Los Altos, CA

School Safety Assessment held February 2021

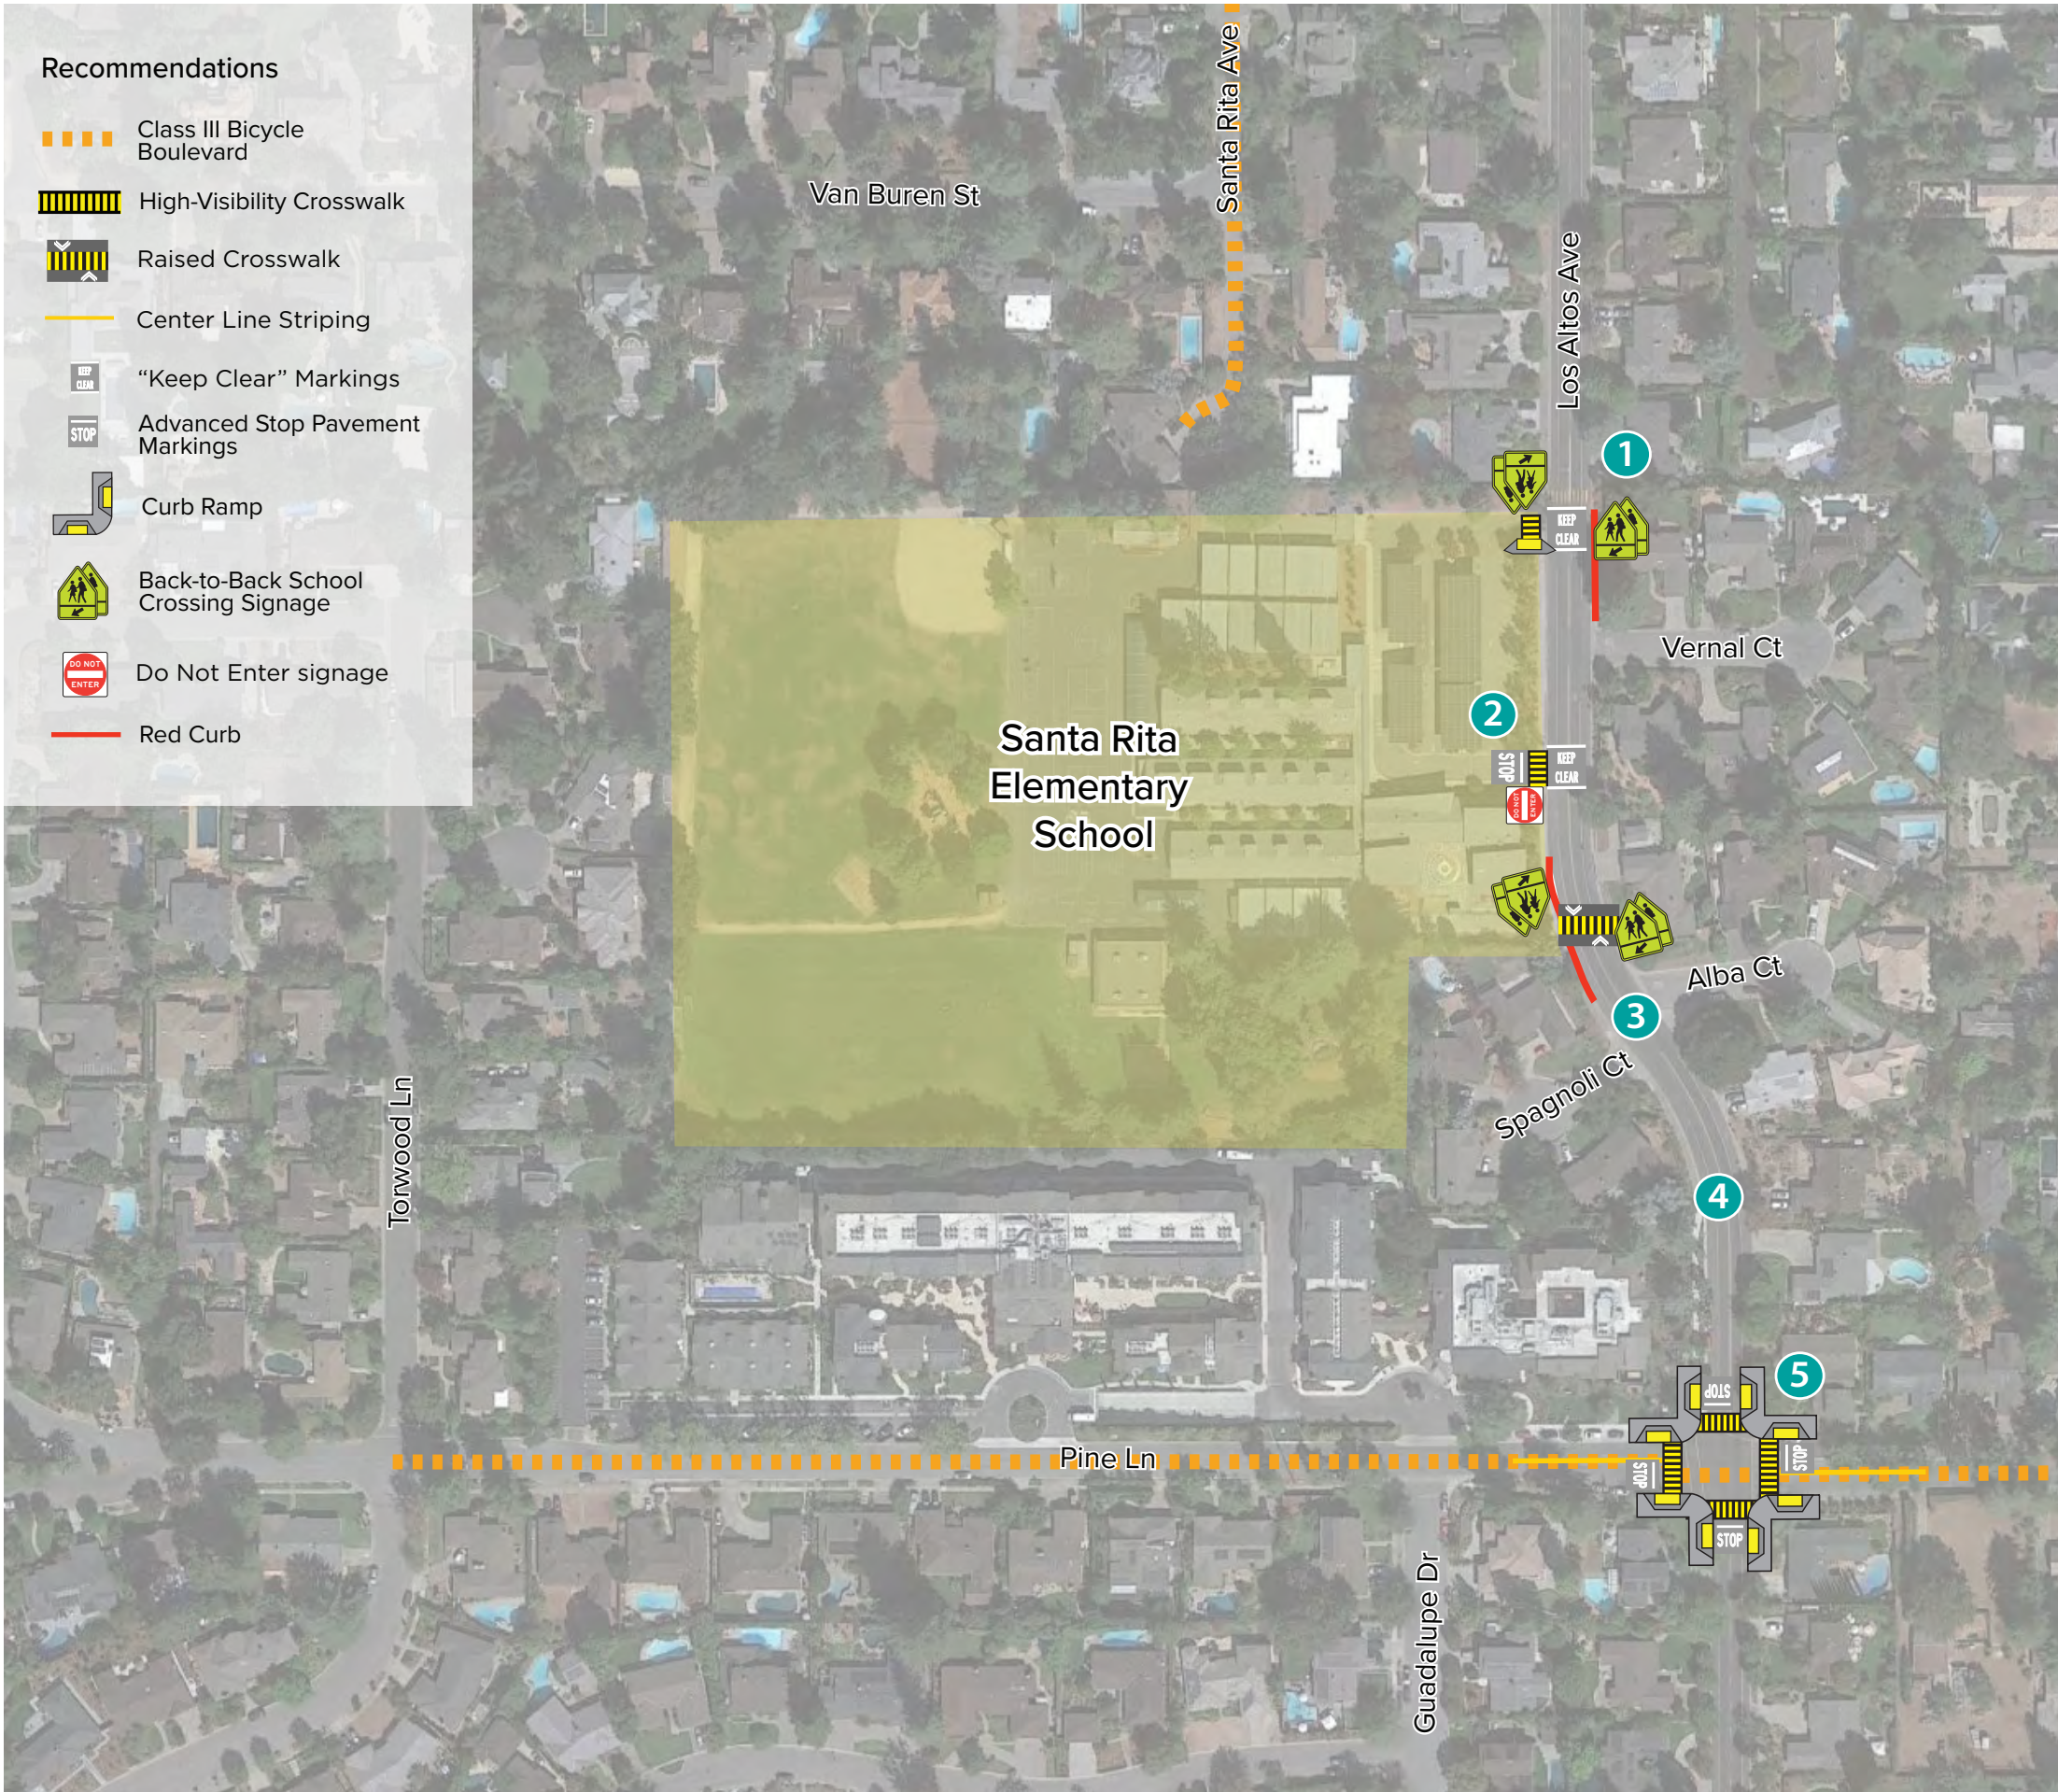
- 1 School driveway loop entrance (Los Altos Ave)**
 - 1a. Reconstruct south corner to accommodate drainage and wider curb ramp
 - 1b. Upgrade crosswalk across driveway to high-visibility

- 1c. Install "Keep Clear" pavement markings in front of school driveway entrance
 - 1d. Update school crossing signage to most recent
 - 1e. Consider RRFB at crossing of Los Altos Ave

- 1f. Extend red curb on southeast side of crosswalk
 - 1g. Consider putting out traffic cones on the edge line on both sides of crossing during drop-off and pick-up periods to prevent parking near crosswalk

- 2 School driveway loop exit (Los Altos Ave)**
 - 2a. Install stop pavement markings and advance stop bar at exit
 - 2b. Upgrade crosswalk across driveway to high-visibility

- 2c. Install "Keep Clear" pavement markings in front of school driveway entrance
 - 2d. Install "Do Not Enter" signage in addition to "Wrong Way"
- 3 Los Altos Ave at Alba Ct**

- 3a. Update school crossing signage to most recent
 - 3b. Construct raised crosswalk
 - 3c. Consider RRFB at crossing of Los Altos Ave
 - 3d. Extend red paint 20' on either side of the crosswalk

- 4 Los Altos Ave (south of Spagnoli Ct)**
 - 4a. Reconstruct sidewalk
- 5 Los Altos Ave and Pine Ln**
 - 5a. Install high-visibility crosswalks on all legs of intersection

- 5b. Install stop pavement markings and advance stop bar on all legs of intersection
 - 5c. Reconstruct curb ramps on northeast, southeast, and southwest corners

- 5d. Paint 50' centerline at eastbound and westbound approaches to intersection on Pine Ln
